Projekt ARS 2000	<b>Application Note Nr. 97</b> <b>ARS 2340 Redesign Powerstage</b>	Seite 1 v. 3
Ersteller Metronix		Datum 05.10.2007

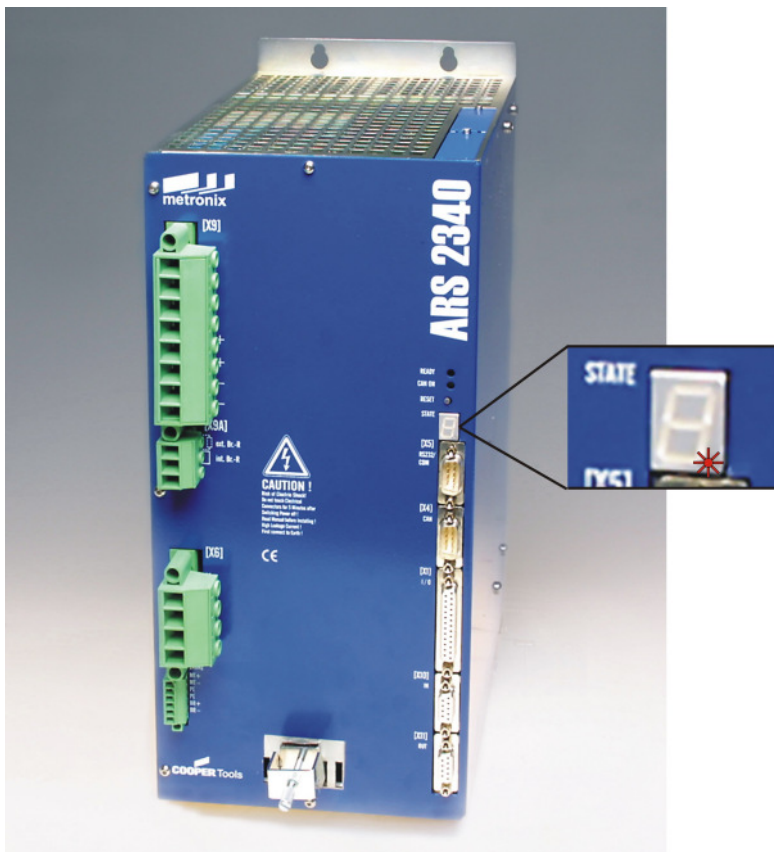
Figure 1: Display of error message on seven segment display

If the user accidentally loads an firmware **earlier than FW 3.4.1.0.2** into a ARS 2340 drive with redesigned power stage, the drive will not start up correctly and shows an error message on its seven segment display. As the firmware is not completely running, the **error message** is shown by using a **blink code** on the decimal point of the seven segment display.

The error code, that is shown here is 25.1. It says, that the **hardware is not supported by the firmware**. The blink code is the following:

If the behaviour, that is explained in chapter 4 occurs, the ARS 2340 servo positioning controller is **not broken and can be repaired by the customer**.

To bring the drive back to operation, the user simply has to download a new firmware with a version number later or equal to FW 3.4.0.1.2 into the drive. Afterwards the drive is ready for operation again.
