This application note describes the effects if the motor cable shield is not connected to the control cabinet back panel or the intended shield connection point on the servo drive. It is intended for users of the servo drives of the smartServo BL 4000-C and ARS 2000 series.

Document title	Application Note 122
Filename	APPL122_Effects_of_missing_earthing_of_the_motor_cable_shield_EN.docx
Version	1.0
Year	2022

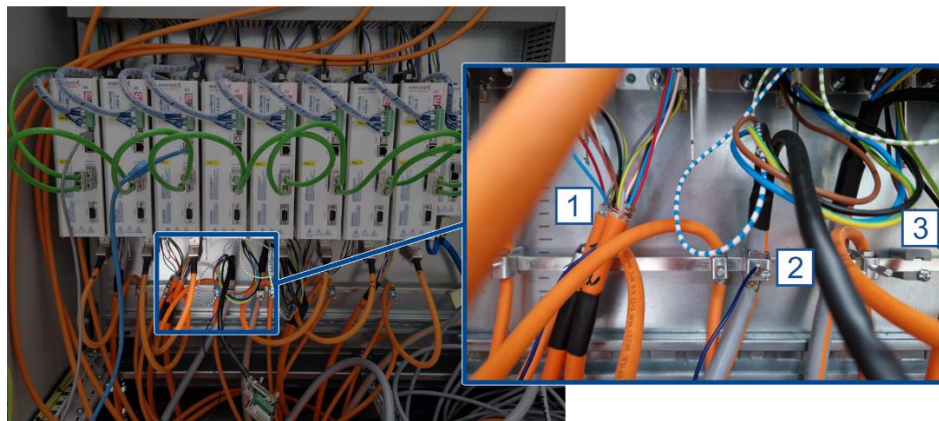
This setup contains the following faults:

- The shield of the motor cable is neither stripped nor fixed with a shield clamp **1**
- Motor and encoder cables are fixed with a common shield clamp **2**
- The unshielded part of the motor cables is much too long **3**

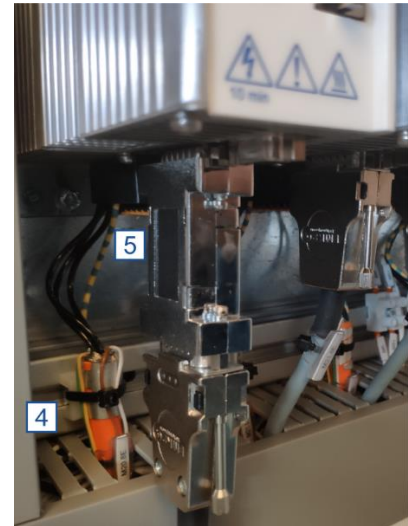
The following faults can be seen in this setup:

- The shield clamp is mounted on an anodised mounting profile and not as intended on the servo drive mounting plate **4**
- The shield clamp is not mounted electrically conductive **4**
- The motor shield should instead be placed on the mounting plate with a large conductive surface **5**

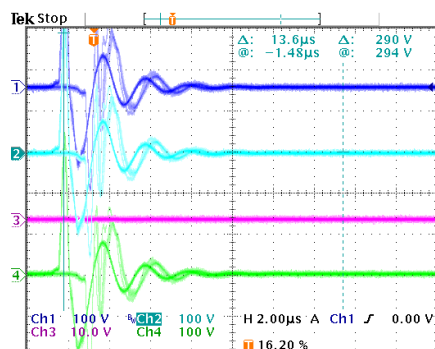
Figure 1: Measurements of the voltage on lines in the motor cable (30m) with incorrect earthing of the cable shield (left) and correct earthing of the cable shield (right).

Shielding not connected to the Weidmüller connector, i.e. **no** conductive connection via the motor cable.

Disturbances with approx. 290V amplitude! Danger to life!

Always make a good conductive connection between the motor shield and the servo drive housing before switching on the power stage in order to avoid high voltages on lines carried in the motor cable (brake, motor temperature).

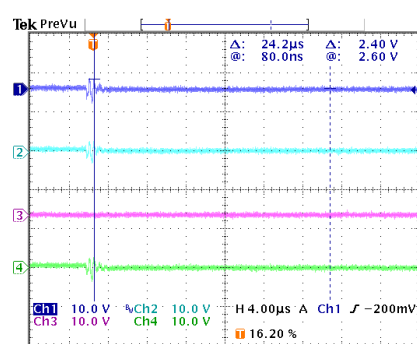
Complete shield connection via encoder cable and motor cable.

Interference with approx. 2.4V amplitude: OK.
